CONNECTICUT RIVER BASIN  
NEW BRITAIN - SOUTHTON, CONNECTICUT

# SHUTTLE MEADOW RESERVOIR DAM CT 00162

## PHASE I INSPECTION REPORT NATIONAL DAM INSPECTION PROGRAM

MARCH 1979

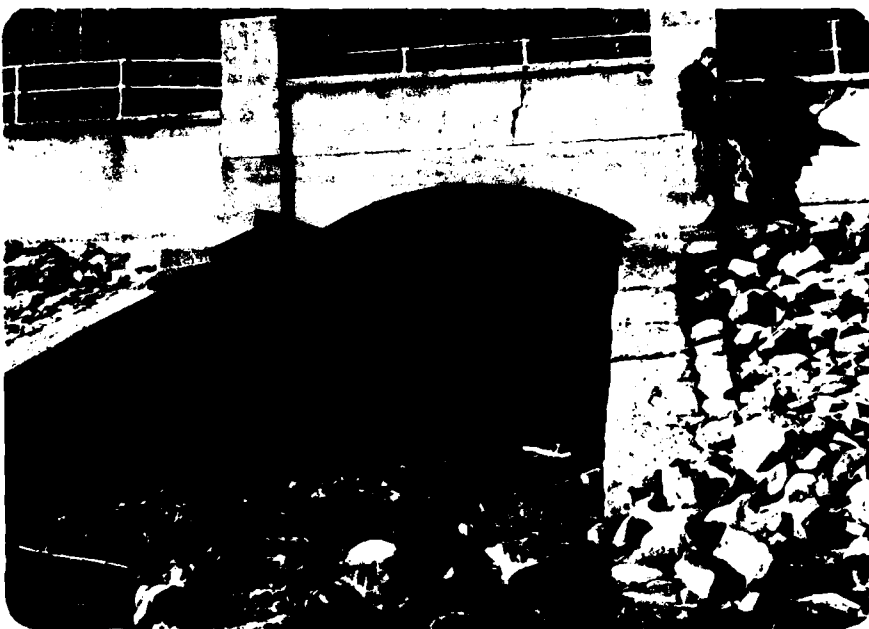
c. Appurtenant Structures - There are several cracks in a concrete wall supporting the roadway passing over the left diversion canal inlet to the reservoir. The most severe cracking is to the right of the canal inlet as shown in Photos 3 and 4. The cracks have offset varying amounts, the largest amount being about 1.2 inches. The roadway pavement adjacent to the cracked area is in good condition.

PHOTO 3 - Left diversion inlet. Note cracks in roadway bridge abutment.

1. Wet areas at the downstream toe of the dam should be monitored periodically for increased seepage. The water flow from the observation well should also be monitored.
2. Cracking of the concrete wall supporting the roadway should be repaired. The displacement should be monitored periodically for any worsening of the condition.
3. The small amount of stones and mortar missing or deteriorated in the spillway channel sidewalls should be replaced or repaired.
4. Spalling of the coping wall will increase if not repaired.
5. The small depressions on the crest of the dam are not a problem, but should be monitored for worsening of the condition.
6. The valves to the low level outlet pipes are located on the downstream side of the dam which means that even in the closed position, the pipe running through the dam is full of water under pressure.
